## ECOFLAT 1

FROM FOUNDATION REPAIR TO PREMIUM RENTAL UNIT

March 2012

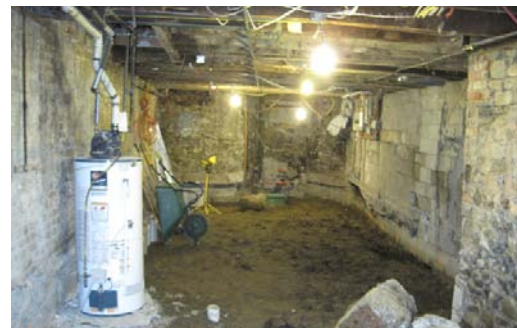
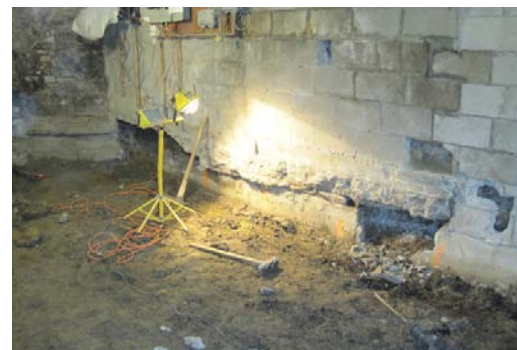
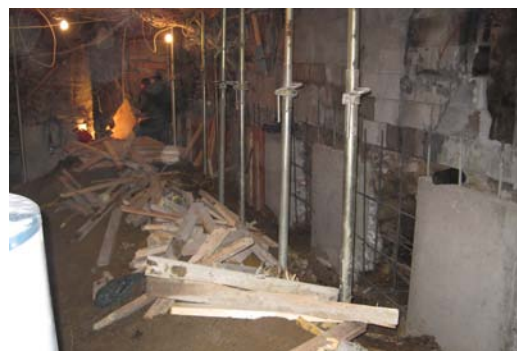
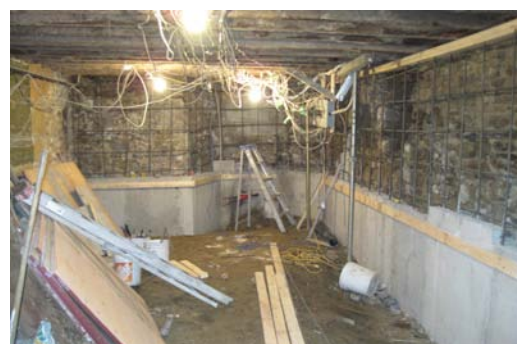
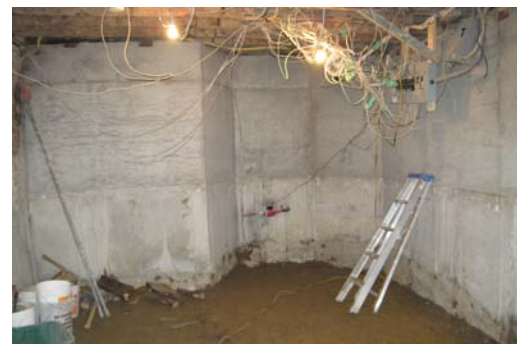
At that point we found some peculiar voids below the foundation walls, where the footings should have been. We discovered that a previous owner had dug out the basement, below the footing level. This left the footing sitting on a ledge of soil, which quickly began to crumble due to the weight and groundwater action. As a result parts of the building had sunk significantly and were still sinking. This handy work was hidden behind a layer of face block so it was not apparent until after some intensive explorations using a long drill-bit.

The second problem was that the rubble walls were in poor condition and crumbling. To further complicate things, half of the east foundation wall is directly on a laneway, so it had to support the weight of passing vehicles, some of them trucks. This vehicle "surcharging" was bowing the already weak wall inward. The repair solution was to cast a new 8" thick new concrete wall directly in-front of the rubble foundation wall and connect it to the floor system with steel brackets. That wall was completed in a single concrete pour and it made the basement almost feel like new.

Following that we reorganized the wiring, which was like unravelling a very large knot. For good measure we put a new panel in the basement and one in the office above. We then ran into a problem with the drains because we could not achieve the slope that was required by our building inspector, who made us roll a pool ball through the drain. Since a substantial slope is required to do this, we had to lower all the drains by about 16". Unfortunately our garage was in the way so we had to cut through the floor slab it to attach to the sewer line. While this was a very costly and labour intensive exercise, it allowed us to run all new drains for the building and run electrical and water service to the garage.

After some anxiety, we worked out a solution with our structural engineer. First, we underpinned the foundations with reinforced concrete. This involved digging 3' holes under the foundations every 12'. Steel reinforcing was put inside the hole then covered with a form and filled with concrete. Our concrete sub-contractor did this four times, which resulted in a completely footings for the entire building. It was a real relief to see the building supported on a new 3' high and 3' thick concrete footing. An added benefit was that we could lower our floor level substantially, giving us much higher ceilings.

While we were at it, we cut a new window into the side of the building, increased the size of several window openings and removed a bearing wall. This created a single open space and brought ample natural light into the unit. All of these moves relied on steel beams to support the existing masonry walls.
