## GARDEN AVENUE RENOVATION

REPORT 1

April 2012

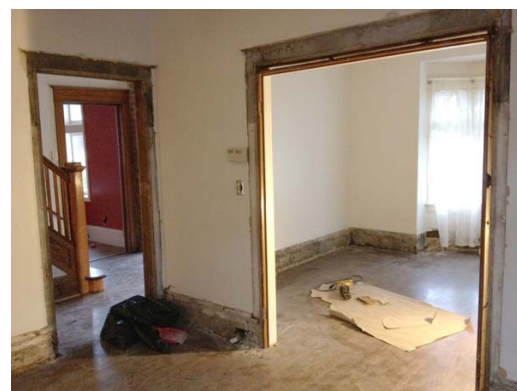
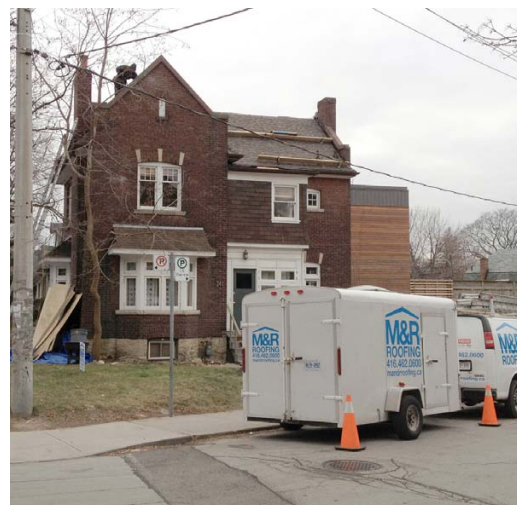
Once all the plaster and lathe was removed from the walls we could really see what shape the bones of the house were in. The first task was to replace and move an existing steel beam in the ground floor. Initially, we hoped to re-use the existing beam but it was undersized and inadequately supported on the two ends: half was resting in an original window opening propped up by 2x4s and half on the edge of the rubble wall. Furthermore, the beam was installed too low

which meant that the floor above settled. The replacement beam rests on a new concrete block tied into the foundation walls. Shifting it slightly to the east allows adequate space for the new basement stair opening.

As mentioned above, the ground floor sagged to a low-point in the middle of the house. The floor was so out of level, the builder wasn't able to jack up the floor to level it out. As such, we decided to re-build the entire ground floor structure to ensure a flat solid surface going forward. The kitchen will really benefit from a level floor as it is much easier to install cabinets on a level surface than having to level each cabinet to accommodate a sloped floor. Although the second floor also has a slight slope to it as well, we decided to leave it as is since it isn't as critical to have a level surface in the smaller bedrooms upstairs.
